ENGINEERED LINING SYSTEMS

Lake Asbury North Dam CCTV inspection of East and West Outfall to Kettle Valves

May 13, 2021

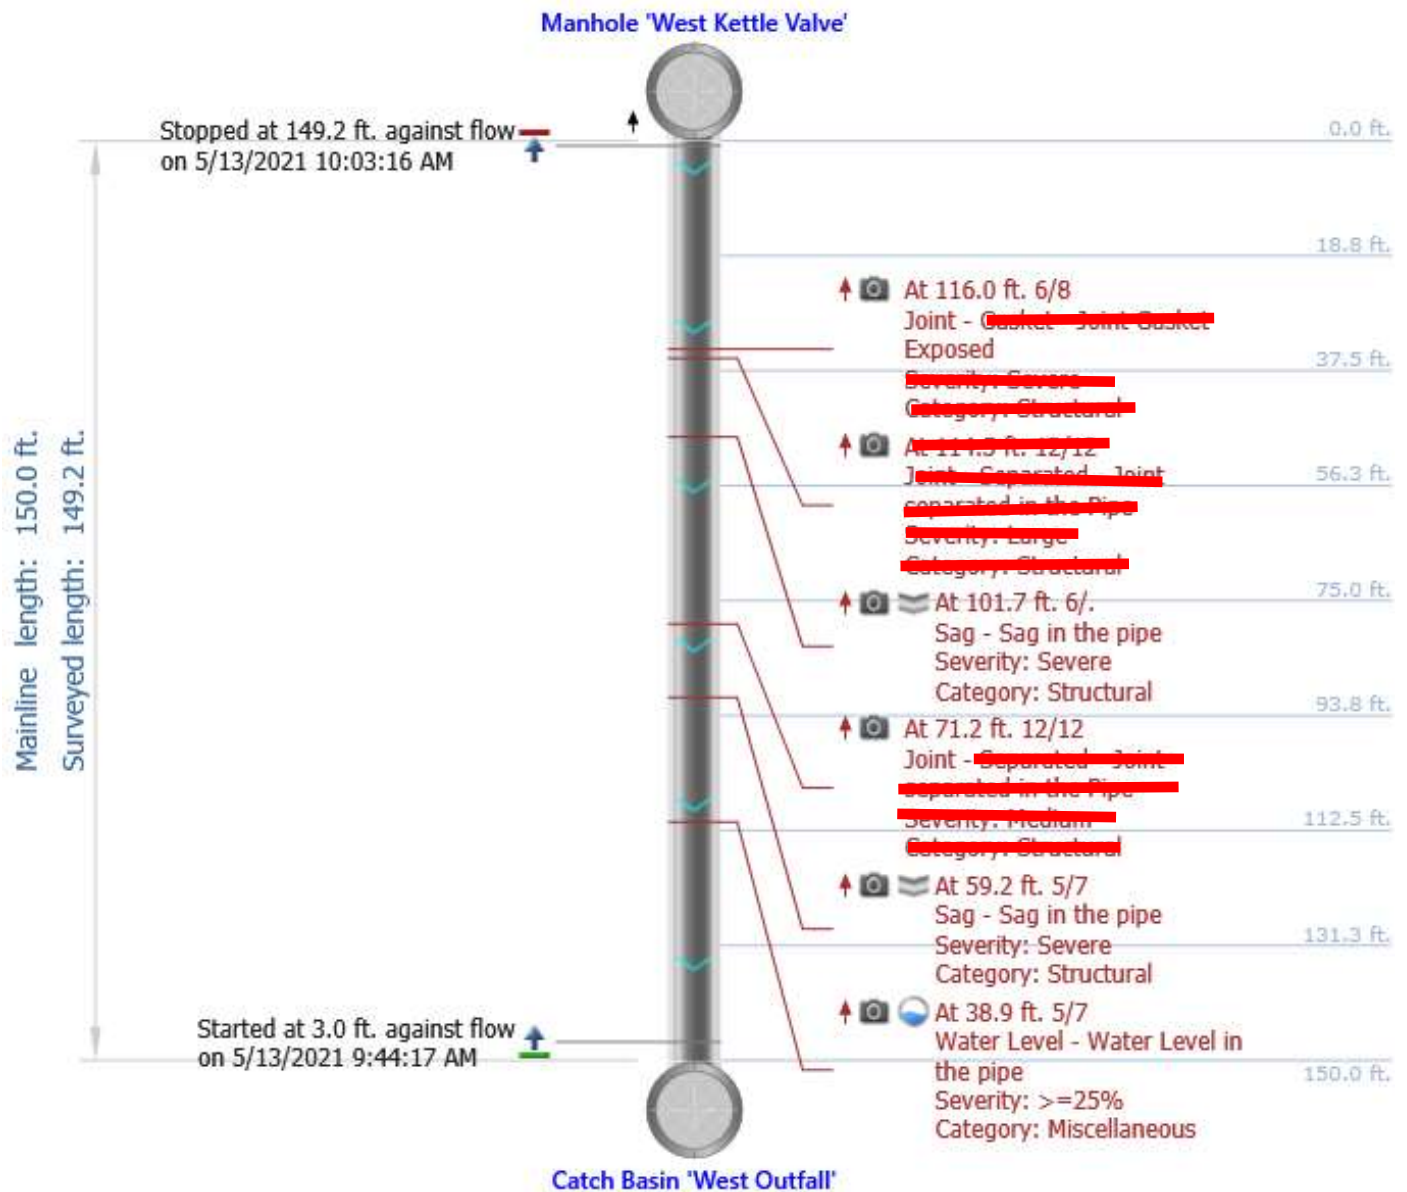
| Project name: 21050089_Lake_Asbury_Pipe_Investigation | Mainline ID: West Kettle Valve to West Outfall | City: Greencove Springs, FL | Address: Lake Asbury North Dam |

1. West pipe run reports calls out joint issues. During the office review we have found minimal issues with joints. There are no visible leaks and joints appear to be fused not gasket-ed. One joint has one small section of the internal part of the fuse that has separated from joint, but looking close at joint seam, the joint appears to be in good condition. All water that is visible appears to be coming from around the valve. We cannot see any active infiltration from HDPE or existing CMP. Also, there was no active water the was visibly flowing at the outfall between the HDPE Liner and original CMP.

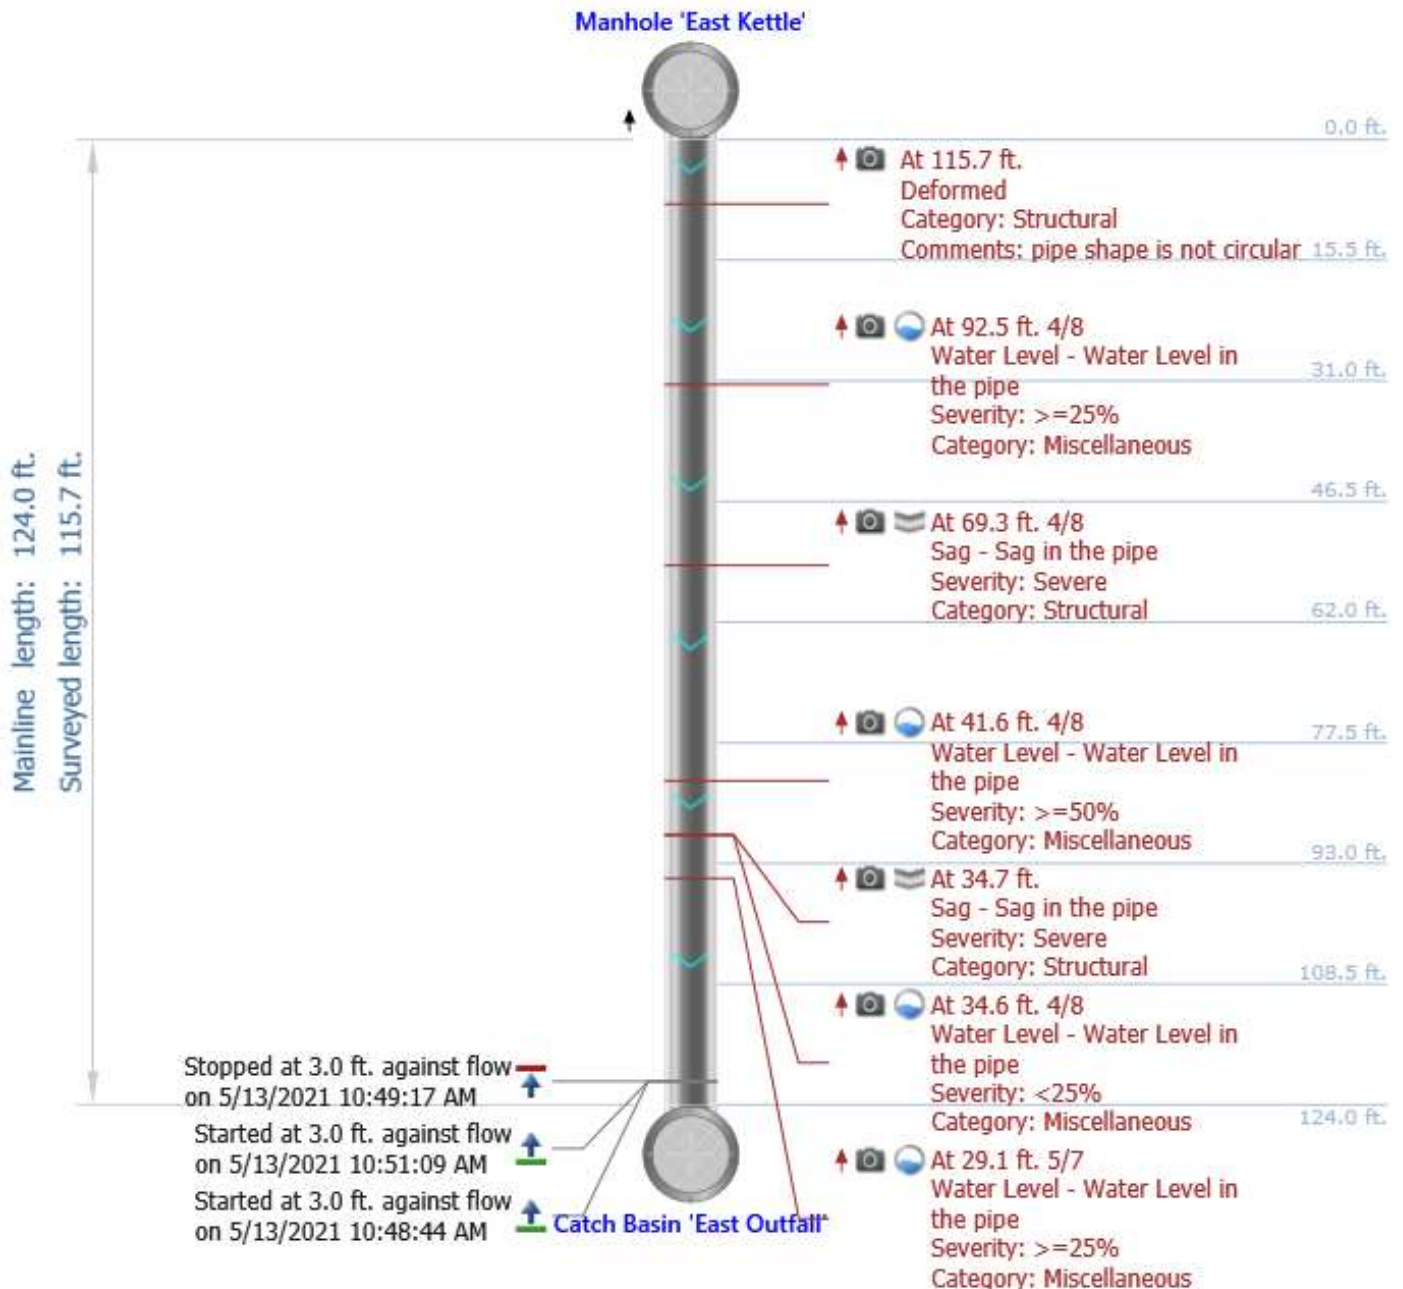
| Project name: 21050089_Lake_Asbury_Pipe Investigation | Mainline ID: East Outfall | City: Greencove Springs, FL | Address: Lake Asbury North Dam |

2. East pipe run report office review. We have found minimal issues with joints. There are no visible leaks and joints appear to be fused not gasket-ed. All water that is visible appears to be coming from around the valve. Valve is in poor condition and needs repair. We cannot see any active infiltration from HDPE or existing CMP. Also, there was no active water the was visibly flowing at the outfall between the HDPE Liner and original CMP.
